DETONATION AND

Knowing the signs and avoiding trouble

PRE-IGNITION

ISSUE 15 DECEMBER 2006

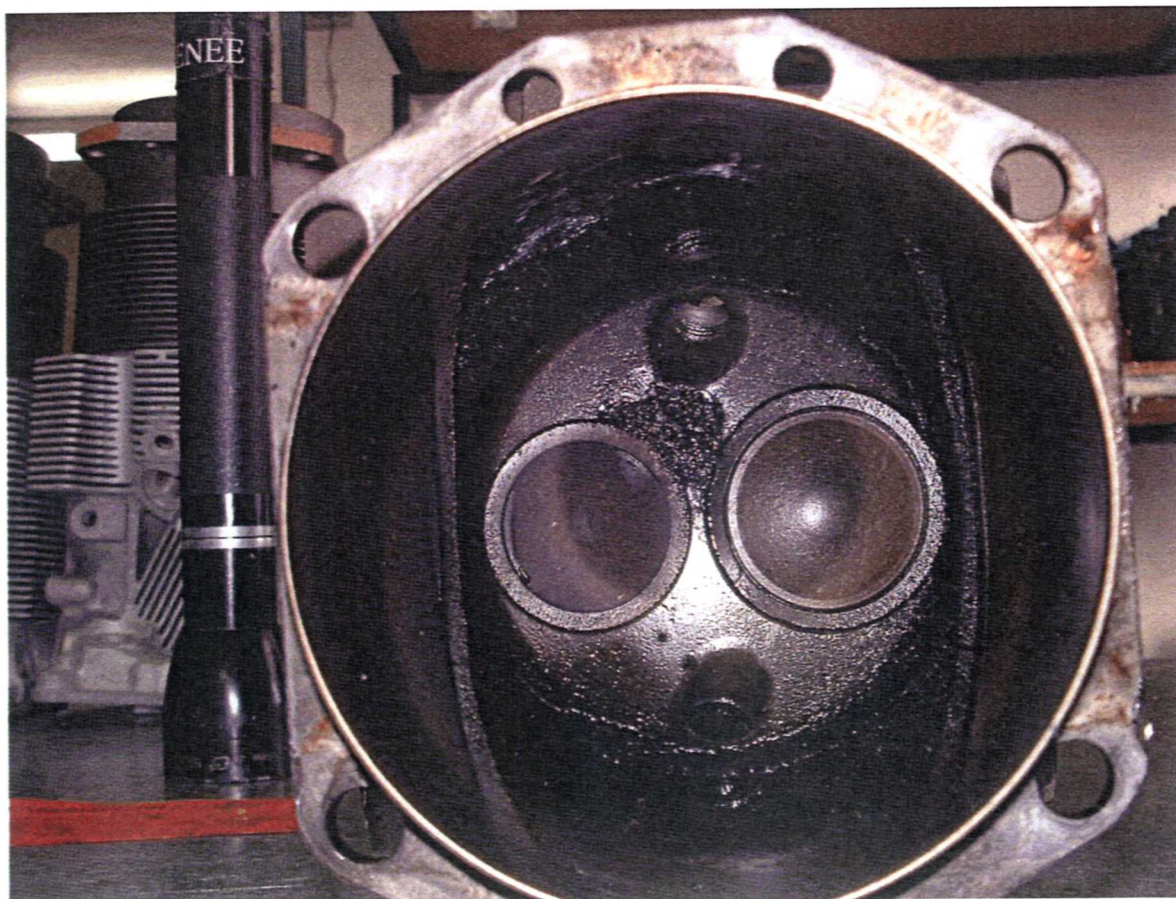
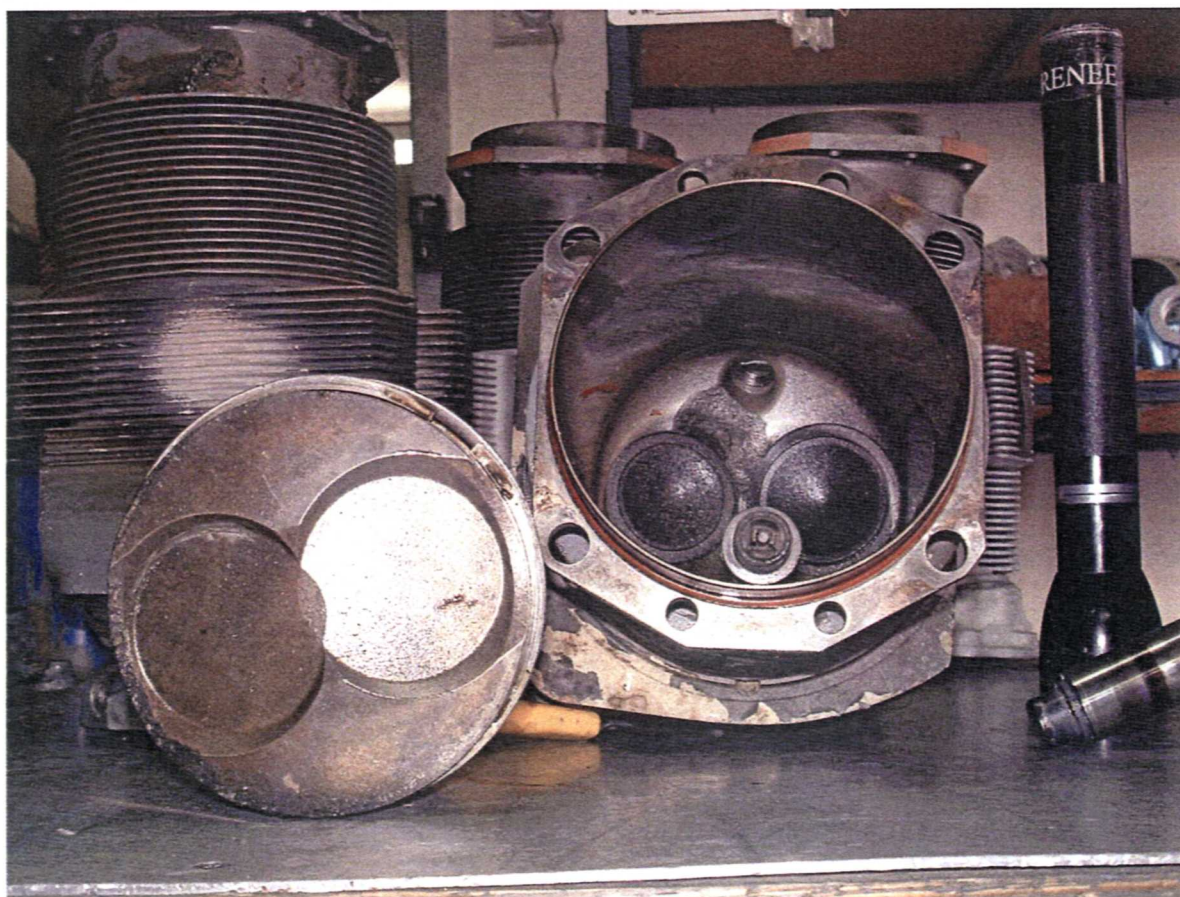
The principle damage can be seen to be an area of pitting in the cylinder head between the spark plug hole and the valve seats. The operator suspected either pre-ignition or detonation was the cause of the damage. Pre-ignition and detonation are totally different phenomena; pre-ignition occurs when there are hot spot deposits within the combustion space to act as an ignition source, whereas detonation is the spontaneous auto ignition of the unburned end gas through an increase in its thermal energy.

In this case there are none of the characteristics of detonation damage here and it should be ruled out as a cause.

Now this is more probable, with the spark plug being a source. If, for some reason, the spark plug is running hot, then it could itself present a source of ignition prior to the spark and result in the damage shown.

The area that appears to be damaged most in these photographs is the area between the spark plug and exhaust port. This is where the cylinder head runs hottest, as it is difficult to cool this area (lack of metal to conduct heat away,

poor cooling fin area around that area and the exhaust port is perpetually dealing with hot gas). Cylinder head cracking is common in this area in engines which are cooled too rapidly because of the poor thermal path from this area, and it is common to see weld repairs between the exhaust port and one of the spark plug holes as a result. So we know that this area runs hot and this further supports the pre-ignition supposition.

The next question is why might the spark plug running excessively hot? In this case the spark plug insulation was damaged, offering one of two failure mechanisms. Firstly, the plug insulation might have been the primary failure, presenting a hot centre electrode, which could then have caused the secondary pre-ignition damage. Alternatively the plug itself may have run too hot, creating a pre-ignition source, which damaged the cylinder head and subsequently shattered the plug insulation.

In this example the evidence does not support detonation as being the cause of the damage. This is not a problem that manifests itself around spark plugs - in fact the spark plugs are the one area that detonation cannot be the problem as detonation happens ahead of the flame front and needs a flame propagation to occur. Therefore, in this case, the octane quality of the fuel is not a contributing factor.

However, the damage is consistent with pre-ignition with the spark plug as the ignition source. The central questions that would need answers to take the investigation further are why the plug is either a) running too hot, or b) what is causing the insulation to fail?

Leaning increases combustion temperatures and there are a few recommended practices to help stop this from causing a problem. First of all, leaning should not be performed at any altitude at power settings above 75% power as this threatens the risk of detonation; however, the reduction in air density above 6,000 feet generally means that a normally aspirated engine cannot make more than 75% above this altitude and so leaning is generally possible at all throttle settings above 6,000 feet in normally aspirated engines.

I have seen a lot of people leaning to peak EGT and beyond, but I much prefer to see pilots lean only to 50 °F on the rich side of peak for reasons that I will not cover here, but perhaps is an area that we can cover in a future edition of Tech Talk. This is particularly significant if operating above 65% power without specialised engine instrumentation. Also of note, when leaning an engine, is that the cylinder head temperature (CHT) is actually a more important marker than EGT, even though this temperature lags the EGT by some margin. If the CHT's are redlined then the mixture should be enriched to cool the head,

Finally, are the spark plugs torqued up correctly with a new copper washer each time they are replaced? Most pilots are unaware that the majority of the heat transfer from a plug is through the gasket and seal area and so a good thermal contact in these areas is essential. Too often do you see copper washers being re-used when changing spark plugs, without a thought to either replacement or at least annealing the old washers to soften them. Used, hard washers result in a poor thermal contact and can lead to spark plugs overheating and pre-ignition damage within the engine.

Of course, one obvious way of damaging a spark plug is through mishandling before it even reaches the engine. If you do ever drop a spark plug, particularly onto a hard surface such as the floor, you should always replace it, even if there are no obvious signs of cracking on the insulator. Spark plugs can easily be damaged and it is far better to replace a plug than risk catastrophic engine damage due to failure of the plug insulation after assembly.

Once using the correct grade of spark plug, evidence that the plug is running too hot implies that the engine itself is running too hot (high CHT and EGT), or there is a poor thermal contact between the plug and head. Alternatively it could be that there is poor cooling of the cylinder head caused by poorly fitting baffles for example.

If the primary failure was with the spark plug insulation then this implies that there was either rapid heating / cooling cycles in the cylinder (perhaps combined with plug deposits), or that the plugs were damaged when they were inserted.
